# **Railway Accident Investigation Report (Excerpt)**

Train Derailment Accident between Tsukaguchi and Amagasaki Stations of the  
Fukuchiyama Line of the West Japan Railway Company

June 28, 2007

**Aircraft and Railway Accidents Investigation Commission**

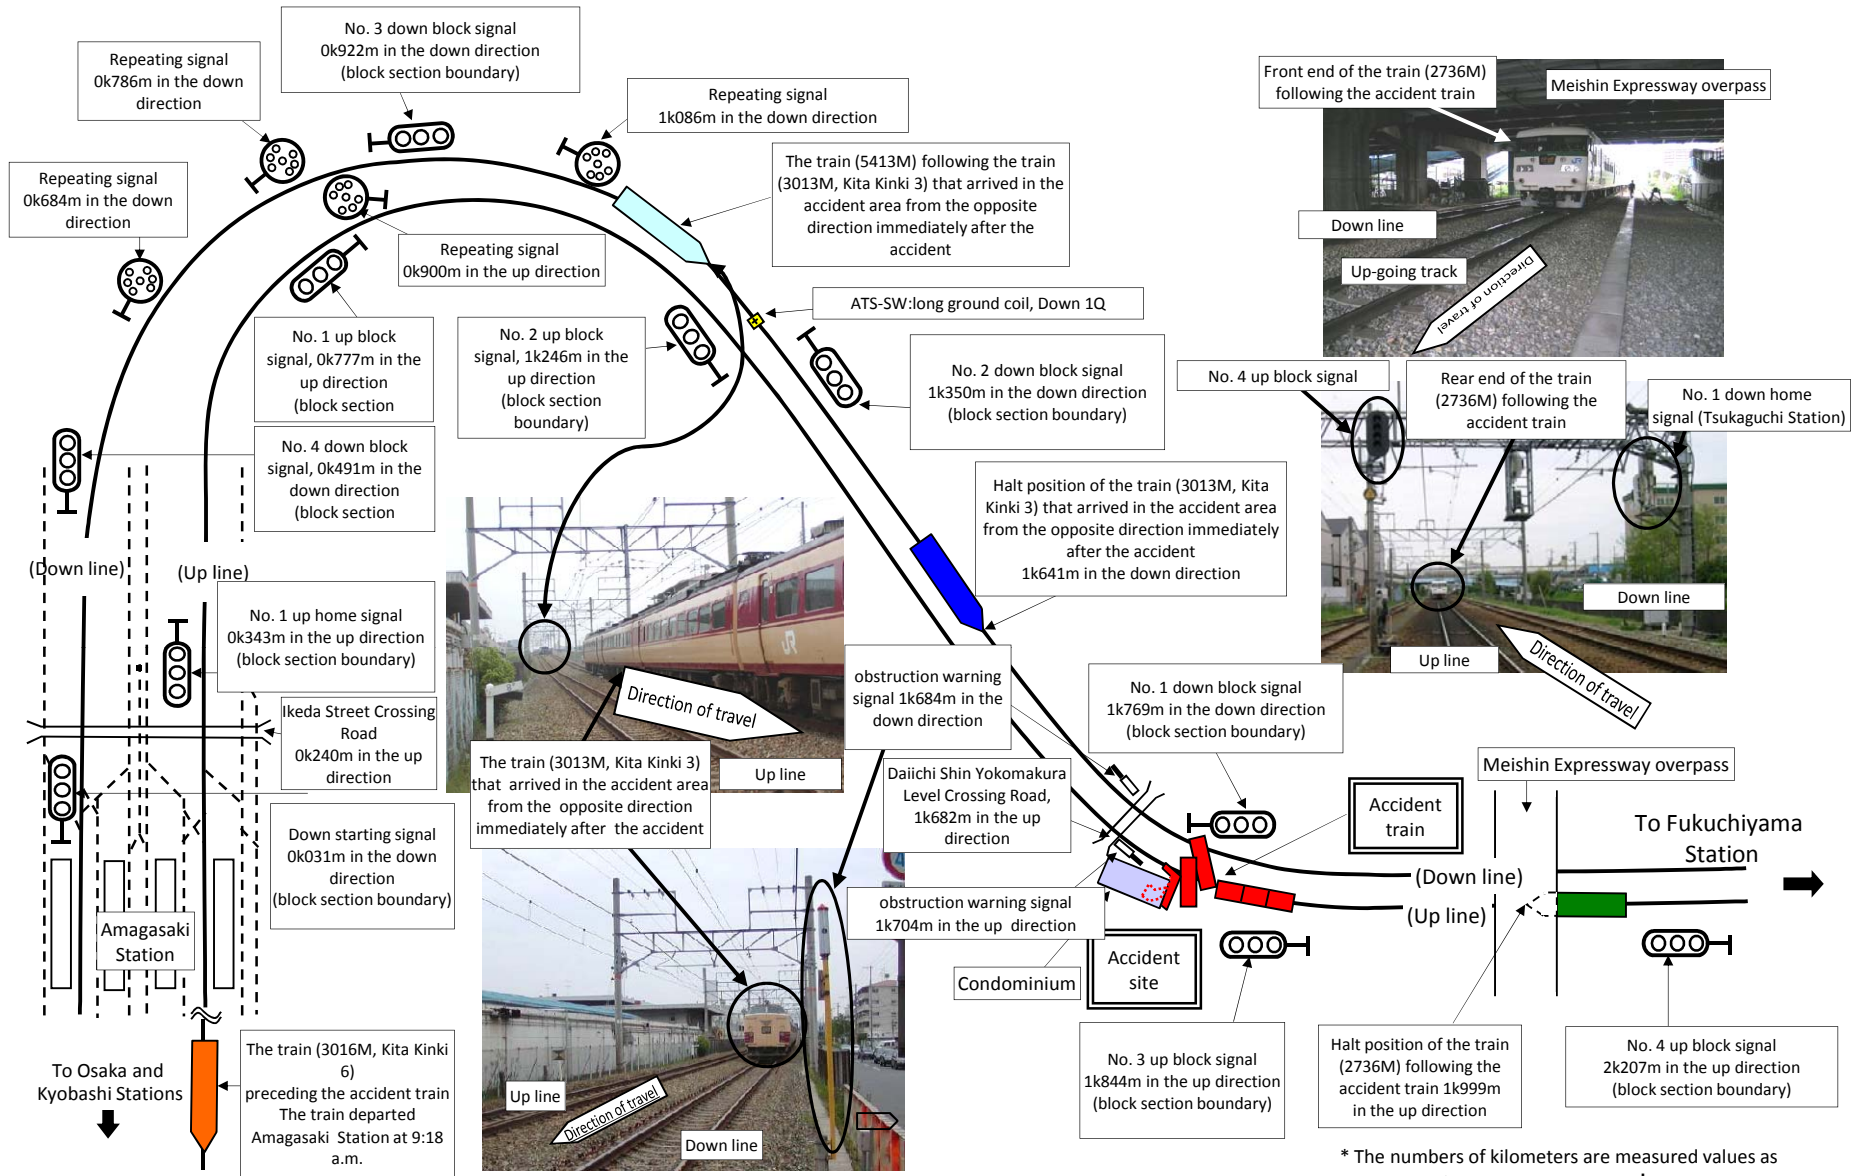
Figure 12 – Schematic Diagram of the Derailment of the Train

It is considered highly probable that the train driver's delay in applying the brake resulted in the entry of the train into a 304 m-radius rightward curved track at a speed of approximately 116 km/h, which was far higher than the specified speed limit of 70 km/h, and the running of the train along the curved track at the high speed caused the first car of the train to fall left and derail, which caused the second to fifth cars to derail.
